Home Inspection Report

Inspection Date: Friday, August 06, 2004

**805 Sir Richard Road
Tallahassee, FL**

Prepared by:
Ability Home Inspection, Inc.

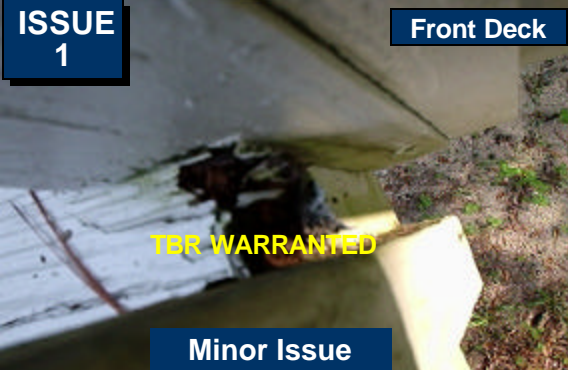
<p>ISSUE 1</p> <p>Front Deck</p>

Issue Number: 1 **Location: Front Deck** **Minor Issue**
Painted-over wood rot noted at several places on deck. Have WDO inspector review and have qualified tradesperson make repairs.

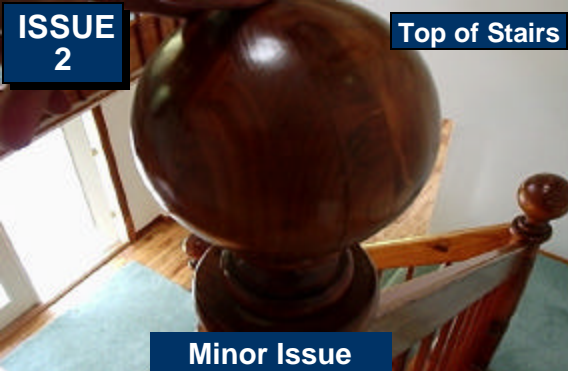
Issue Number: 2 **Location:** **Top of Stairs** **Minor Issue**
Banister handrests are loose (safety issue). Have qualified tradesperson tighten.

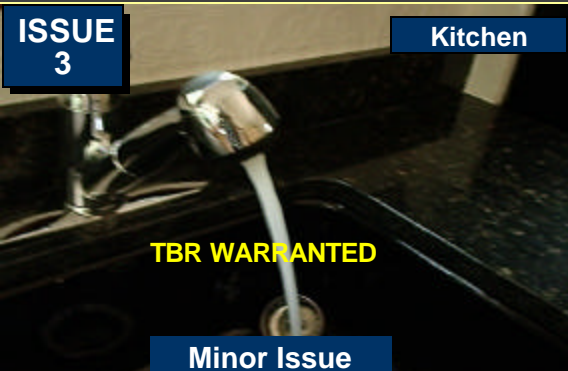
Issue Number: 3 **Location:** **Kitchen** **Minor Issue**
Water pressure is low, but not unusable. If desired, have qualified plumber review pipe diameters to ensure supply pipes are not too narrow and suggest ways to boost water pressure.

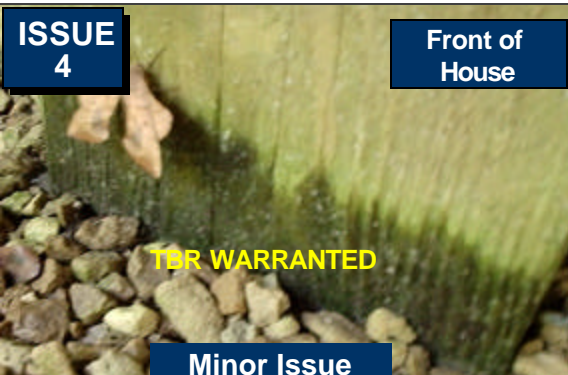
Issue Number: 4 **Location: Front of House** **Minor Issue**
Water staining found on siding below condensate line outflow, at front of house. Have WDO tradesperson check for wood rot.

<p>TBR WARRANTED</p> <p>Minor Issue</p>	<p>Water staining found on siding below condensate line outflow, at front of house. Have WDO tradesperson check for wood rot.</p>

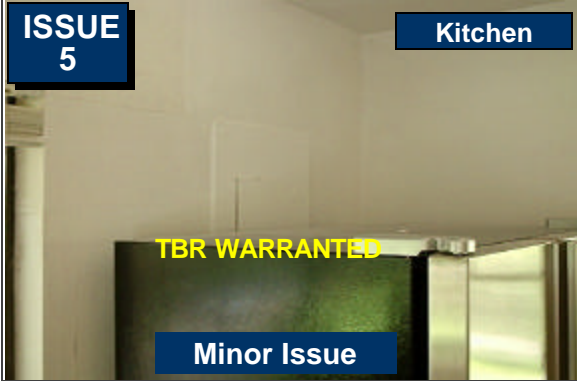
ISSUE 5	Kitchen

Issue Number: 5 **Location:** **Kitchen** **Minor Issue**
Refrigerator blocking electrical service panel. Although refrigerator moves easily on rollers, NEC code suggests a 6 foot operating area in front of the panel.

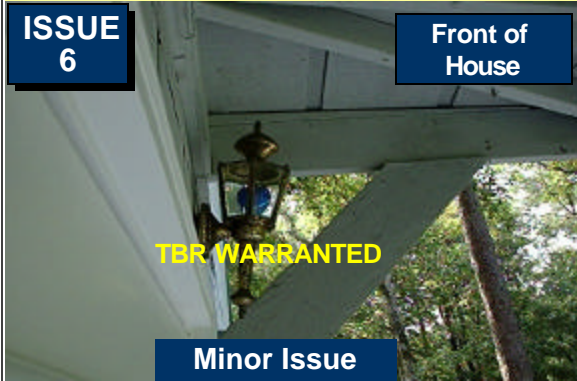
Issue Number: 6 **Location:** **Front of House** **Minor Issue**
Both front porch lights were found inoperative at time of inspection. Have bulbs replaced and if still not operational, have qualified electrician address.

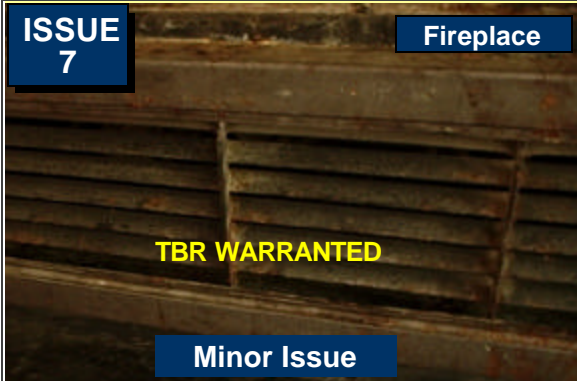
Issue Number: 7 **Location:** **Fireplace** **Minor Issue**
Fireplace fan, while functional, made a noise when operating. Have qualified electrician correct the fan.

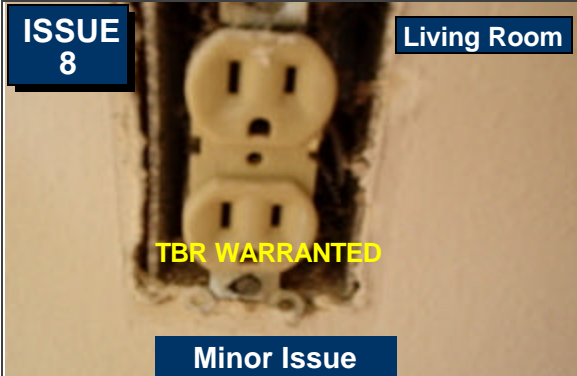
Issue Number: 8 **Location:** **Living Room** **Minor Issue**
Several outlets were missing switch plates, this one was found in the living room.

<p>TBR WARRANTED</p> <p>Minor Issue</p>	Several outlets were missing switch plates, this one was found in the living room.

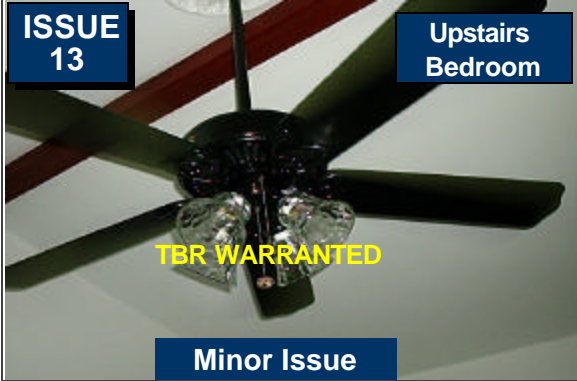
<p>ISSUE 13</p>

Issue Number: 13 **Location:** **Upstairs Bedroom** **Minor Issue**
A humming noise was noted when ceiling fan was operated. Have qualified electrician correct.

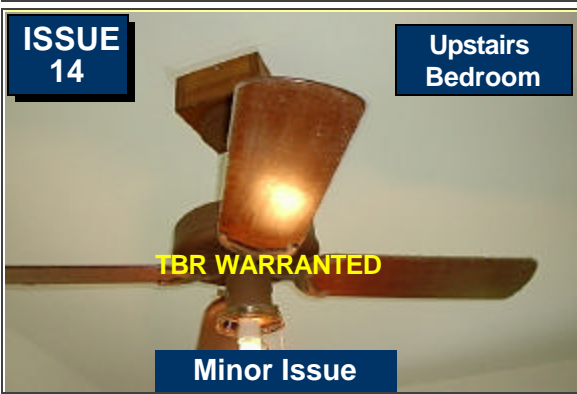
Issue Number: 14 **Location:** **Upstairs Bedroom** **Minor Issue**
Ceiling fan weak, barely rotated. Have qualified electrician verify motor is properly functioning.

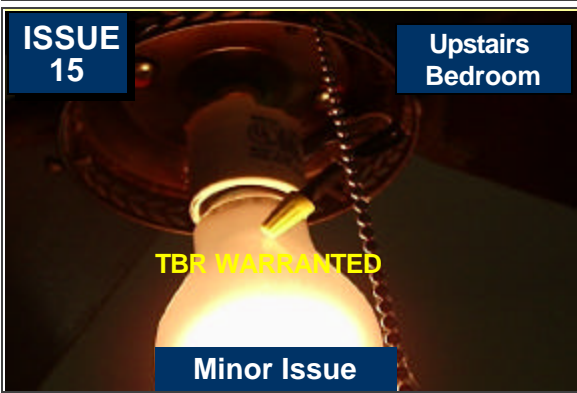
Issue Number: 15 **Location:** **Upstairs Bedroom** **Minor Issue**
Ceiling fan without fixture enclosure has an electrical wire casing in direct contact with bulb. Have qualified tradesperson correct.

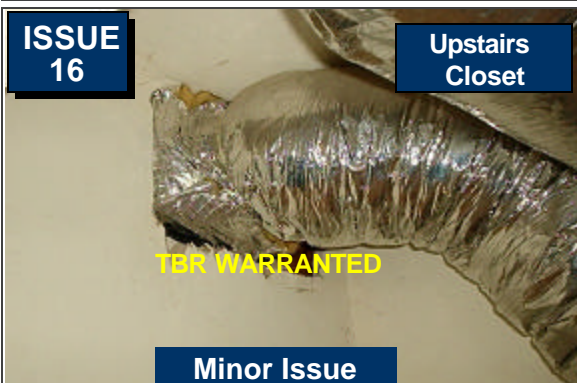
Issue Number: 16 **Location:** **Upstairs Closet** **Minor Issue**
Flex vent hole in closet is not properly sealed. Have qualified tradesperson fix.

<p>Upstairs Closet</p> <p>TBR WARRANTED</p> <p>Minor Issue</p>	<p>Flex vent hole in closet is not properly sealed. Have qualified tradesperson fix.</p>

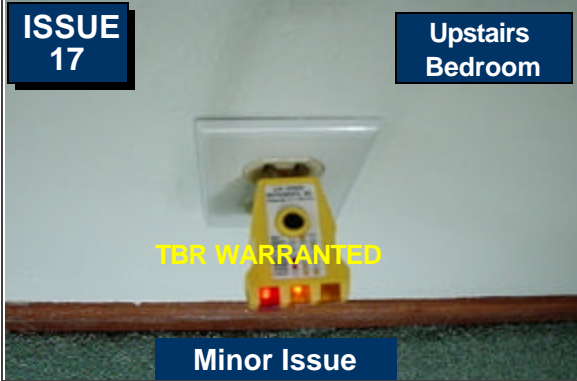
ISSUE 17

Issue Number: 17 **Location:** **Upstairs Bedroom** **Minor Issue**
Reverse polarity found at this outlet. Have qualified electrician repair.

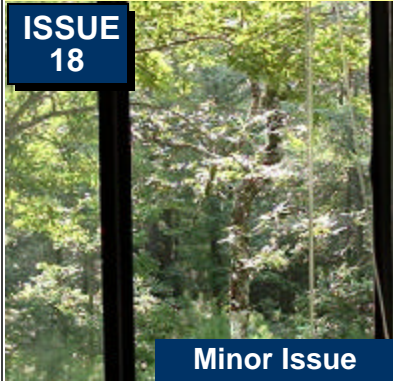
Issue Number: 18 **Location:** **Upstairs Bedroom** **Minor Issue**
Screen missing. Have screens installed by qualified tradesperson.

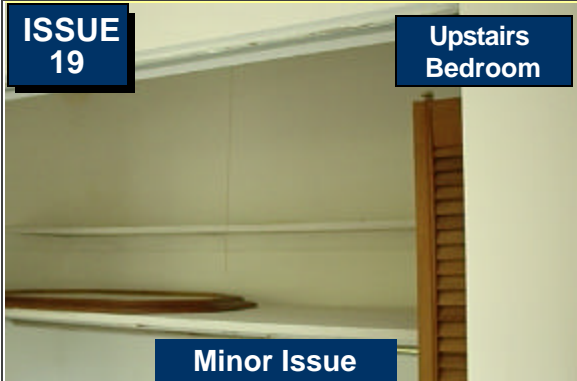
Issue Number: 19 **Location:** **Upstairs Bedroom** **Minor Issue**
Closet door not hung. Have closet door rehung by qualified tradesperson (if desired).

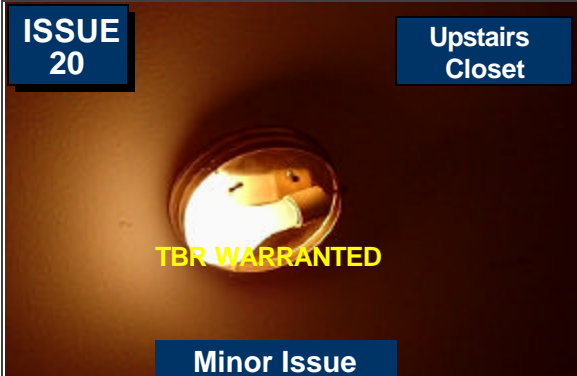
Issue Number: 20 **Location:** **Upstairs Closet** **Minor Issue**
Closet light enclosure missing (safety issue). Have qualified tradesperson install an new fixture.

Upstairs Closet Minor Issue	Closet light enclosure missing (safety issue). Have qualified tradesperson install an new fixture.

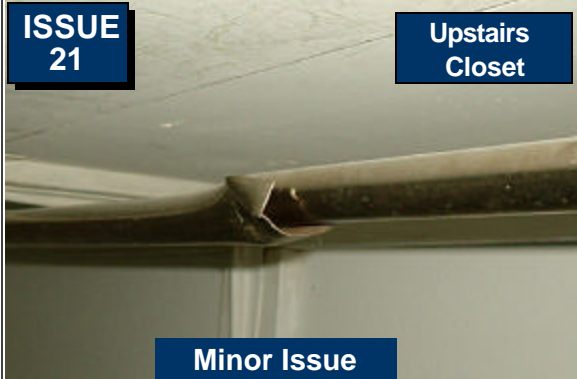
ISSUE 21

Issue Number: 21 **Location:** **Upstairs Closet** **Minor Issue**
Closet coat rack bar bent. Have bar reshaped and resealed.

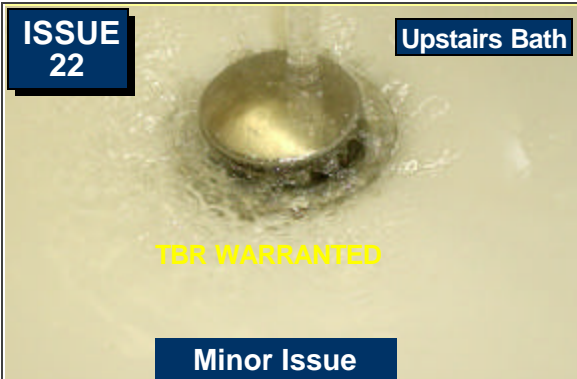
Issue Number: 22 **Location:** **Upstairs Bath** **Minor Issue**
Plunger not closing fully. Have qualified plumber or tradesperson address.

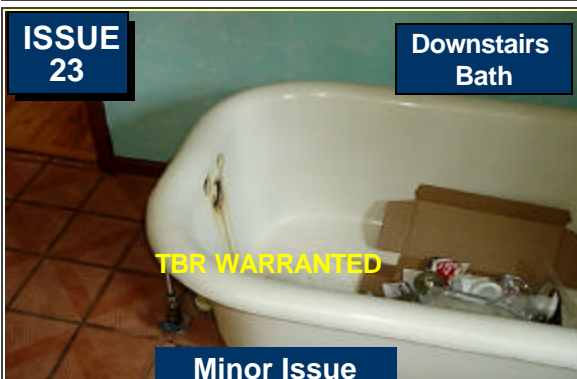
Issue Number: 23 **Location:** **Downstairs Bath** **Minor Issue**
Tub is not fully installed. Have qualified plumber complete installation and test.

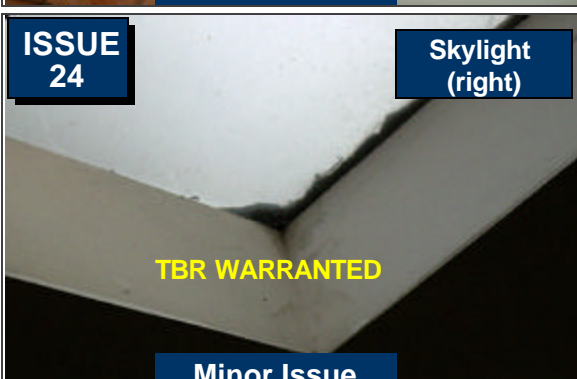
Issue Number: 24 **Location: Skylight (right)** **Minor Issue**
Evidence of past water penetration in corner of right skylight.

Skylight (right) Minor Issue	Evidence of past water penetration in corner of right skylight.

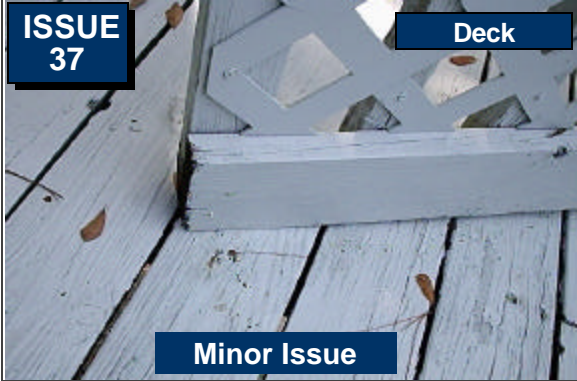
<p>ISSUE 37</p> <p>Deck</p>

Issue Number: 37 **Location:** **Deck** **Minor Issue**
Deck gate contacts deck. Recommend qualified tradesperson realign gate.

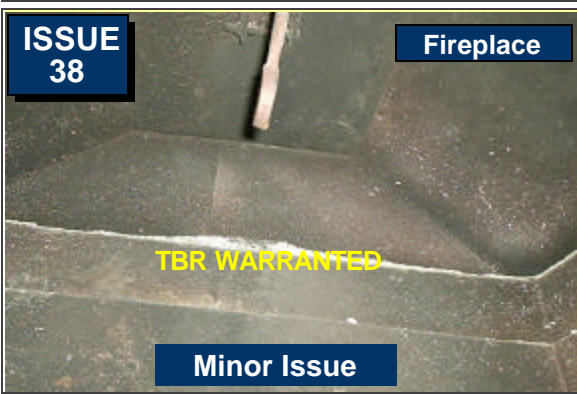
Issue Number: 38 **Location:** **Fireplace** **Minor Issue**
Fireplace flue should be cleaned. Recommend chimney sweep perform annual cleaning service and flue check.

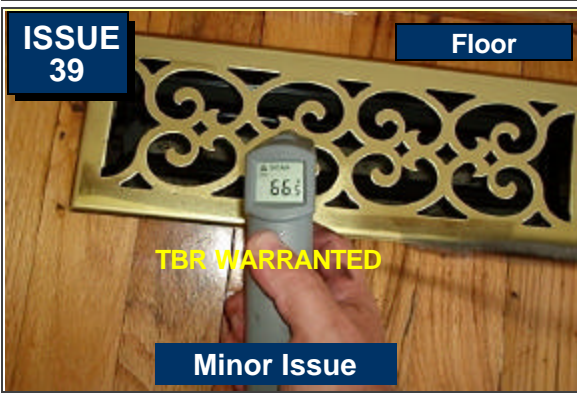
Issue Number: 39 **Location:** **Floor** **Minor Issue**
Heat pump cooling (3 ton) is 14 degrees temperature differential, which is minimal. Recommend annual heat pump maintenance and cleaning by qualified HVAC company for blowers, coils and condenser, also have them check vent system for proper air flow.

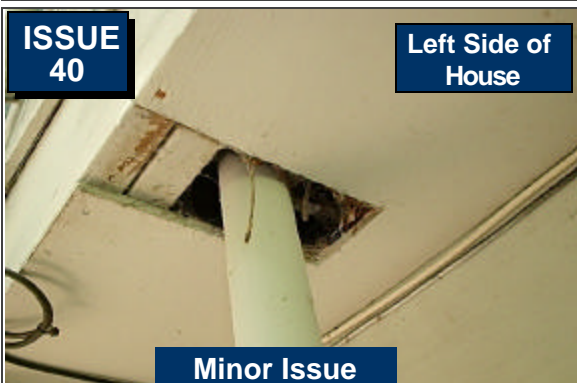
Issue Number: 40 **Location:** **Left Side of House** **Minor Issue**
Exposed gap in soffit. Have qualified tradesperson seal.

<p>Minor Issue</p>	<p>Exposed gap in soffit. Have qualified tradesperson seal.</p>

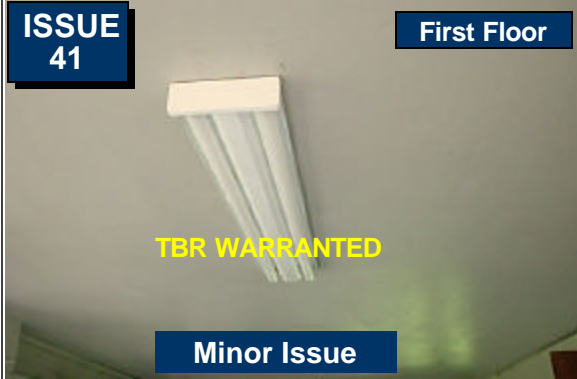
Issue Number: 41 **Location:** **First Floor** **Minor Issue**
Lights without plastic housing on porch and in adjacent room. Have qualified tradesperson install.
