Springs of Florida

FLORIDA GEOLOGICAL SURVEY
BULLETIN NO. 66

SPRINGS OF FLORIDA

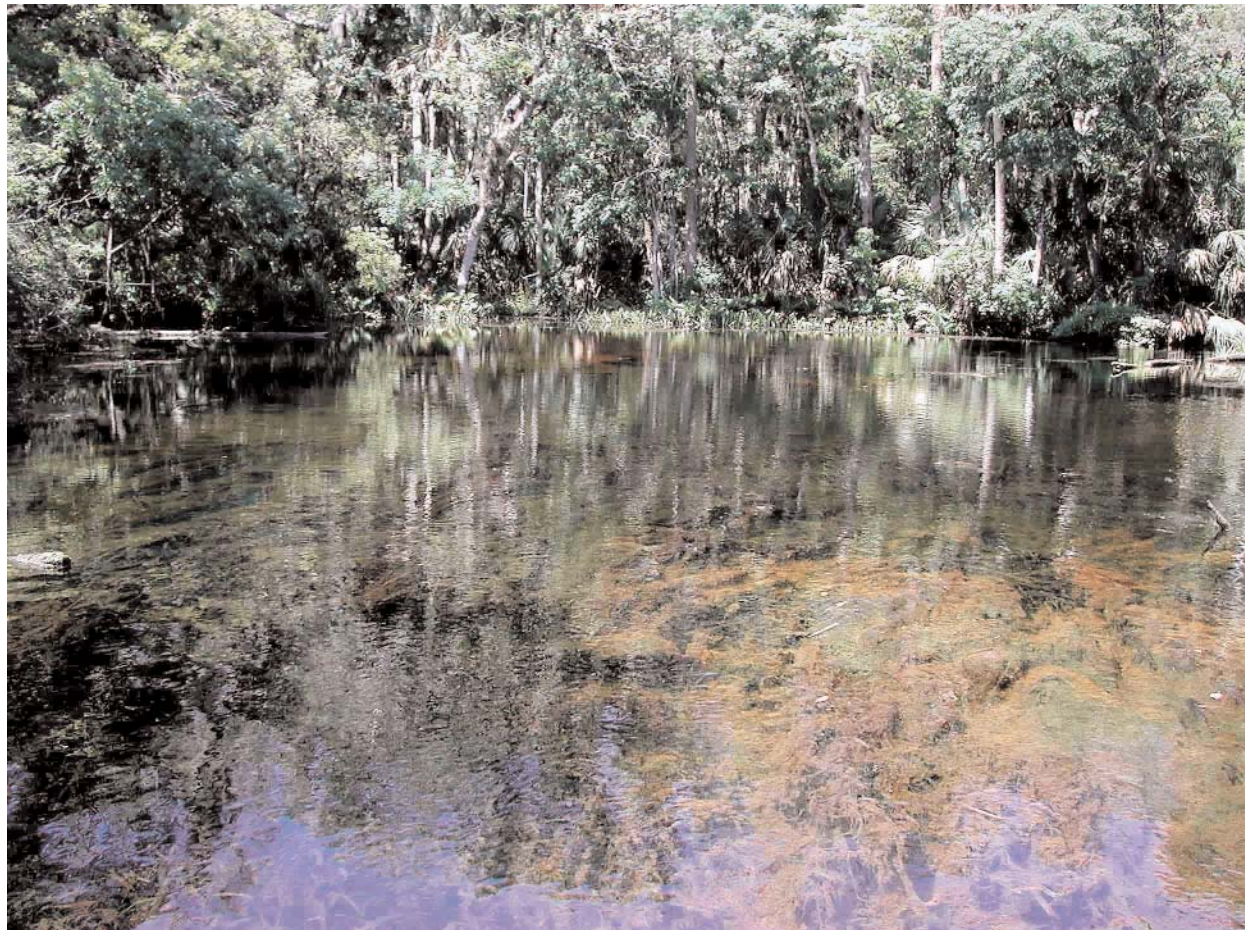
Location – Lat. 28° 42' 29.88" N, Long. 82° 34' 42.80" W (NW¼ NE¼ NW¼ sec. 35, T. 20 S, R. 17 E). Baird Spring No. 2 is located in a small cove off the east bank of Baird Creek approximately 400 ft (121.9 m) downstream from Baird Spring.

Figure 16. Baird Spring No. 2 (photo by R. Means).

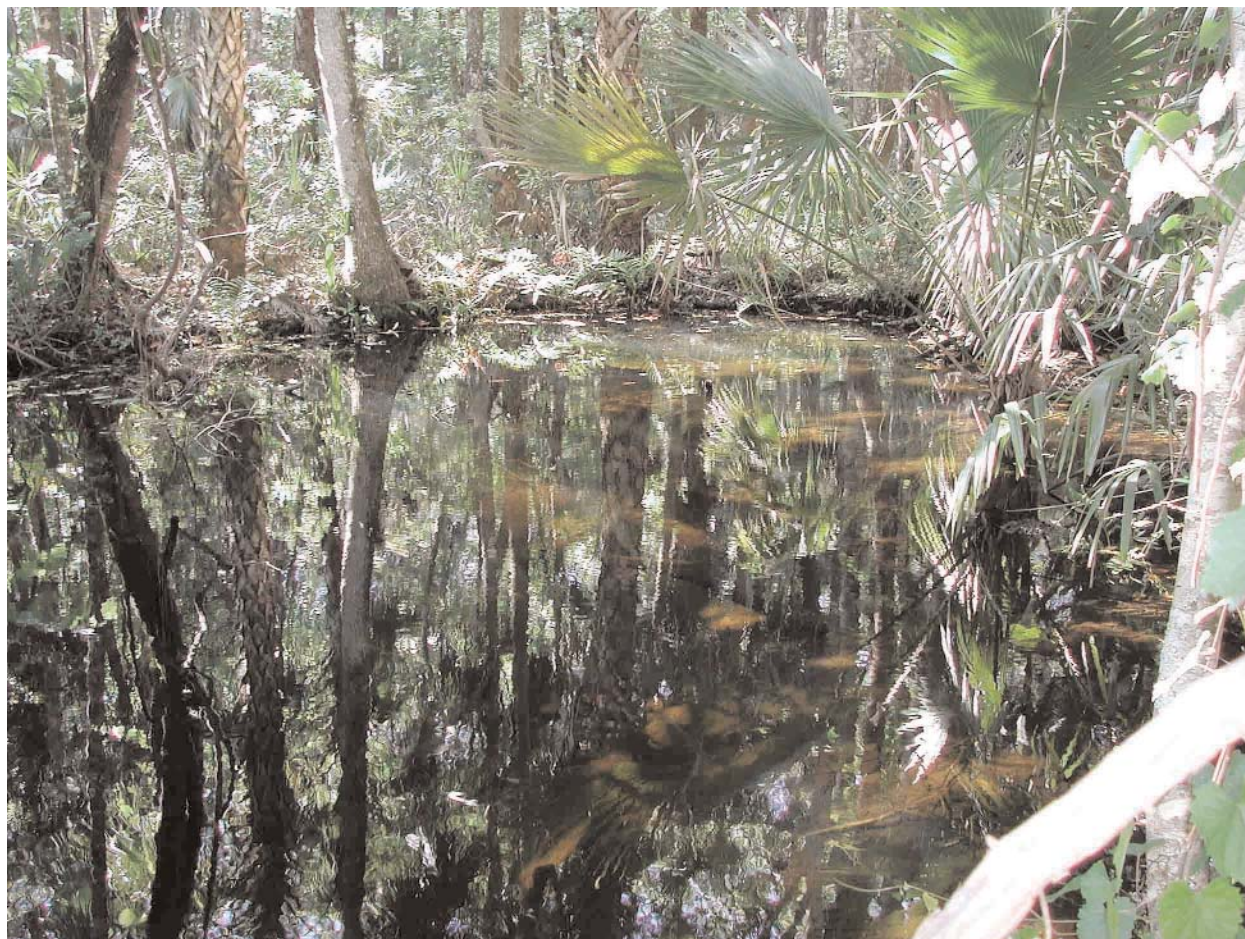
Description – Ruth Spring is composed of two or three separate spring vents. The head spring measures 25 ft (7.6 m) north to south and 17 ft (5.2 m) east to west and is 6.6 ft (2 m) deep. It has no visible boil and has a sand and limestone rubble bottom with abundant logs and detritus. There are areas of thick muck accumulation. Forty feet (12.2 m) downstream from the head spring, the second spring vent discharges out of an elongated crack in limestone measuring 20 ft (6.1 m) long, with depths reaching 12 ft (3.7 m). A third small vent occurs near this vent but is not easily reached. From here, Ruth Spring Run travels approximately 0.1 miles (0.16 km) south and west down a swift narrow run that averages 6 ft (1.8 m) wide and 3 ft (0.9 m) deep. Ruth Spring and Run are under a hardwood and palm forest canopy. All surrounding land consists of heavily forested lowland owned by the Chassahowitzka National Wildlife Refuge.

Figure 34. Ruth Spring (photo by R. Means).

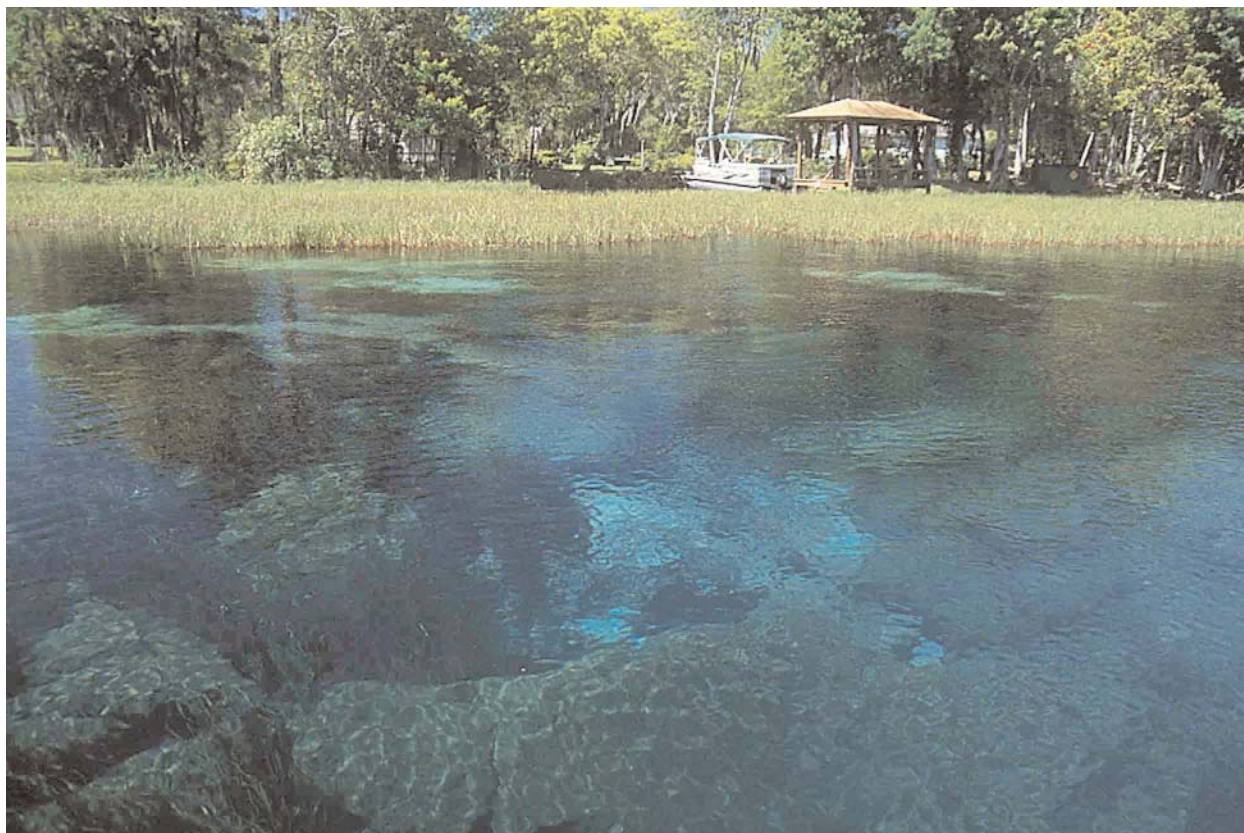
HUNTER SPRING - Lat. 28° 53' 40.0" N, Long. 82° 35' 33.0" W (NW ¼ SW ¼ SE ¼ sec. 21, T. 18 S, R. 17 E). This spring issues vertically from the bottom of a conical depression near the head of a side creek channel feeding the eastside of Kings Bay. Another spring is at the head of the channel. Hunter Spring pool is circular and measures 210 ft (64 m) in diameter. Depth measured over the vent is 13 ft (4 m). The spring has a sand bottom with some limestone near the vent. The spring bottom is choked with dark green filamentous algae, and some *Hydrilla* is present. Water is clear and bluish. There is a large boil in pool center. Land on the north rises to approximately 4 ft (1.2 m) above water and is a county maintained recreational park. Land on all other sides of spring pool is extensively developed with apartments and houses. A concrete sea wall entirely surrounds the pool except for outflow and inflow. There is a square swimming dock floating in the center of the spring pool. This spring was closed to swimming during summer 2001 due to high coliform bacteria levels detected in the water (Eric Dehaven, SWFWMD, pers. comm.).

Utilization - All of Kings Bay and most of its springs are used for swimming, manatee observation, pleasure boating, and scuba diving. The west side of Kings Bay and some islands are part of the Crystal River National Wildlife Refuge. The city of Crystal River nearly adjoins the east side of Kings Bay.
